IBM Problem Resources

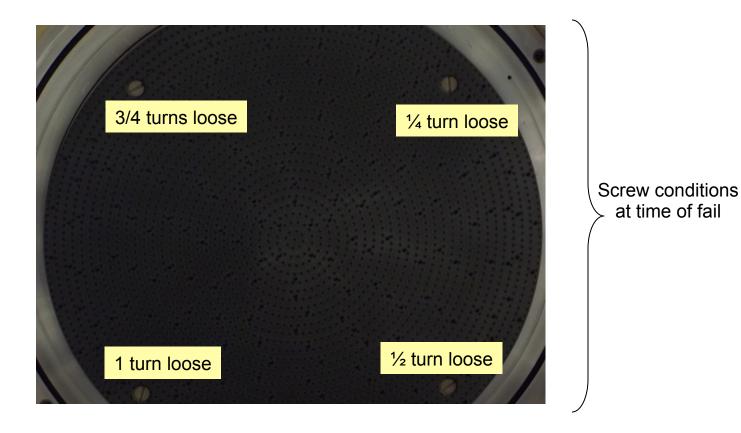
Process gasses flow through the seal plate and are uniformly directed across the substrate surface by way of the hole patterns in the 3 baffles

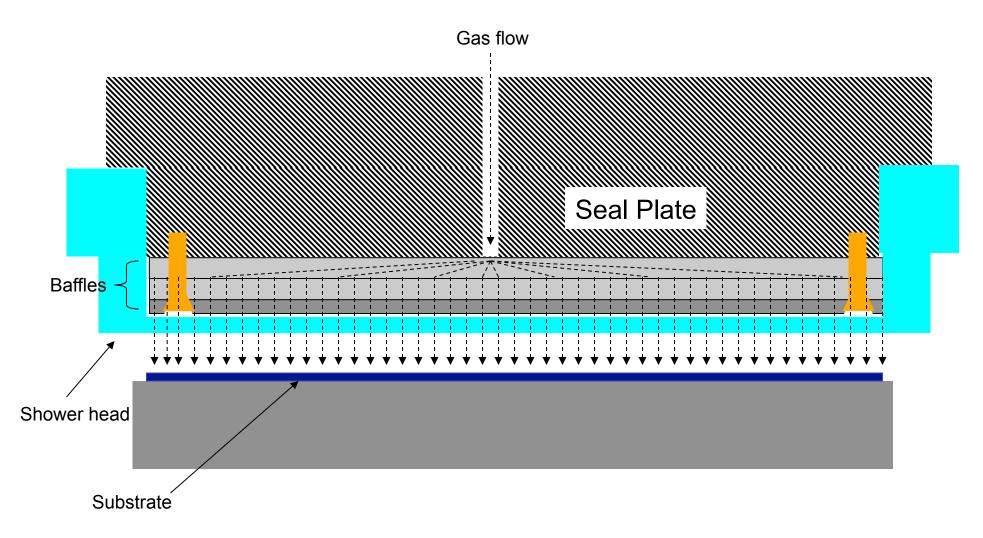
The team first set out to confirm that the loose baffles were indeed causing the localized under etching problem. This was done by purposely installing baffles that were loose in a reverse fashion from the original incident. When this was done, the signature moved as expected to the opposite side of the substrate. Now the team knew that the loose baffles were indeed the point of cause and set out to understand why the baffles were coming loose.

The effort first focused on whether the screws were being installed at the proper torque spec. Torque wrenches were provided and the installation procedure modified to ensure the screws were being installed to the proper specification. Initially this was thought to have remedied the problem, but then there was another occurrence (about 3 months later). The highly intermittent nature of the fail added to the difficulty.
