IBM Problem Resources

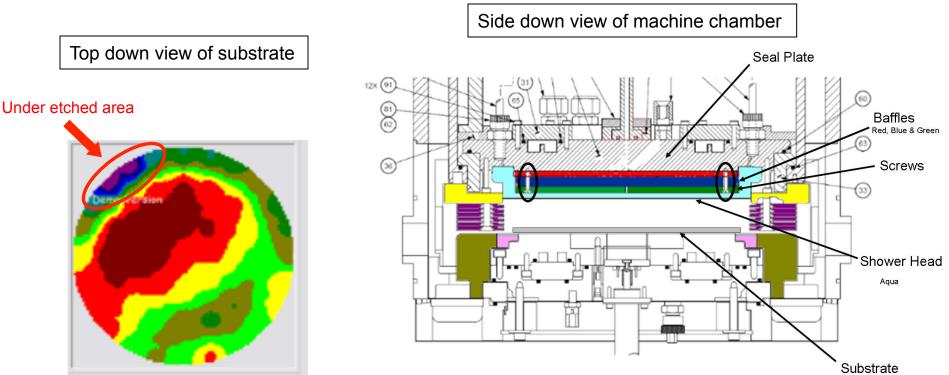
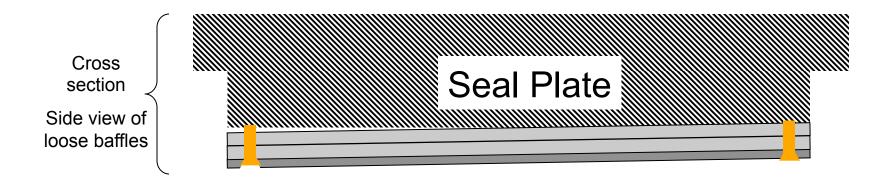
A process designed to uniformly etch a film on a substrate was having a problem that intermittently resulted in a localized area at the edge being significantly under etched. The problem happened on 3 occasions across different machines over a period of 5 months. In each case, when the machine was examined, it was observed that the baffles directly above the substrates were loose on one side. In some cases, the baffles also looked scratched or otherwise damaged. The baffles are a set of 3 plates with hole patterns designed to uniformly distribute gas across the substrate surface in order to provide a uniform removal rate (etch rate).
